Part #50 –

Curing Rotary Valve Shaft Problems

By Mike Stratman

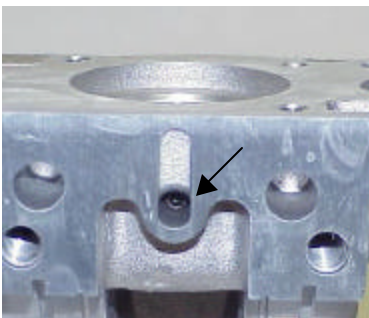
Production Variations: *In an effort to solve the shorten life span on these parts the factory made a number of changes. First, way back in the 532 series engines, the shaft diameter was reduced from 12mm to 10mm to reduce the speed on the shaft and seal. This required the shaft and the seal to be changed. 10 years and factory replacement parts makes running into this 12mm set-up extremely rare. The major changes can when the weep hole or witness passage was plugged off. A passage cast into the crank allows for the vented of the gap between the two facing seals directly behind the water pump impeller. Once either of the seals failed a fluid drip would signify which seal had failed. Unfortunately some operators would mistake this for a water pump housing gasket or crankcase leak and start torquing the water pump bolts or replacing the gasket. This of course did nothing to stop the leak and often times resulted in stripped threads in the crankcase. The photo in Figure #1 shows the passage with a setscrew plug. You can do this yourself with the right size set screw and a little tap and thread savvy. See figure #1*

Figure #1 – A setscrew plugs the cast passage in the upper case half that leads to the area between the two shaft seals. See arrow for setscrew.

The setscrew plug also made it necessary for both seals to fail before there could be an exchange of fluids. But the cavity **must be** filled with a lithium or silicone grease to prevent thermal expansion. I have personally seen the seals be forced out the hole in the freeze plug the first time the newly assembly area came to operating temperature. More about this when we talk about re-assembling the parts.

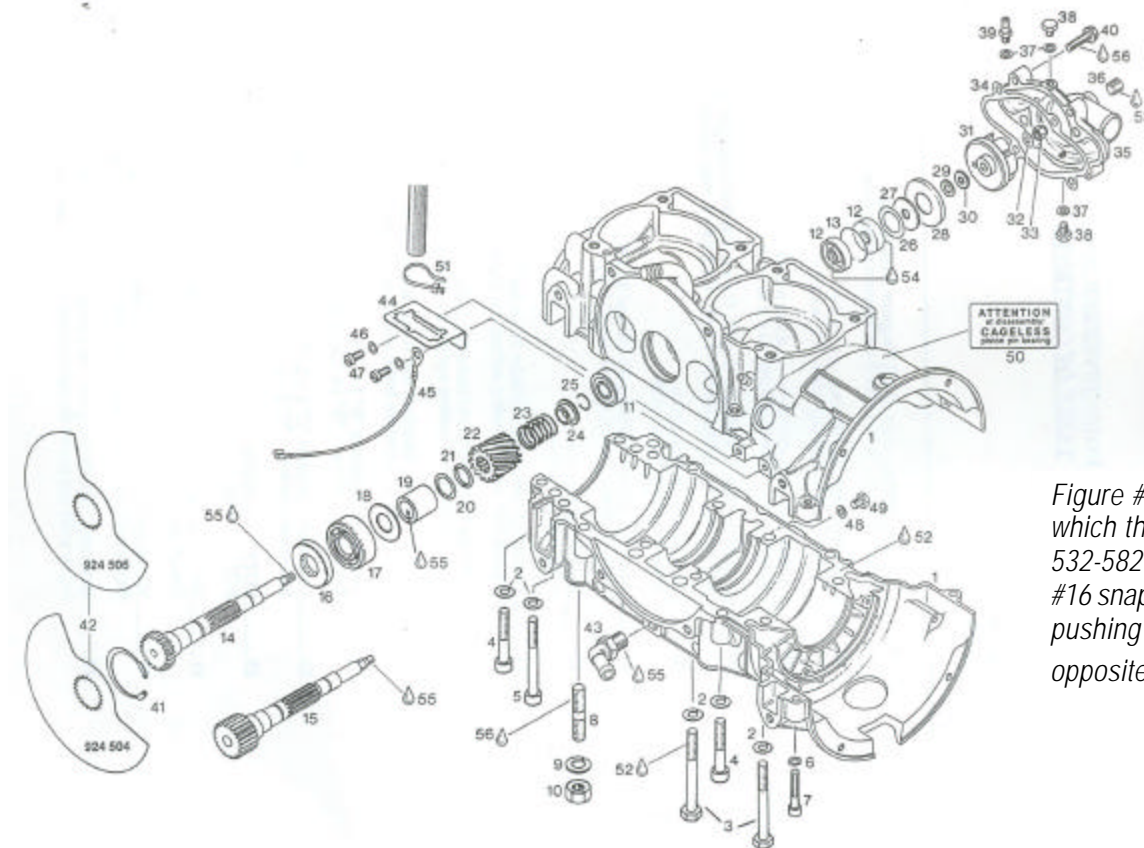
Figure #2 – Shows the order in which the parts located in the 532-582-618 engines. Be sure #16 snap ring is removed before pushing the shaft out from the opposite side of the engine.

Removing the RV Shaft: Surprisingly enough repairing this area can be accomplished in most cases with the engine in the aircraft. You need to remove the water pump housing and impeller as well as the RV cover behind the carburetors. Remove the snap ring #41 in Figure #2. You may also find a metal “freeze plug” #28 guarding the shaft seals. This will have to be destroyed for removal. At this point you can, only with the right tool, hammer the shaft out from the water pump side. See figure #3. Don't even think about using a hammer on the naked end of the shaft. Part #876-612 is an inexpensive (for Rotax) tool that threads onto the end of the shaft and allows you to hammer the shaft out. The spring #23 may compress in the process.

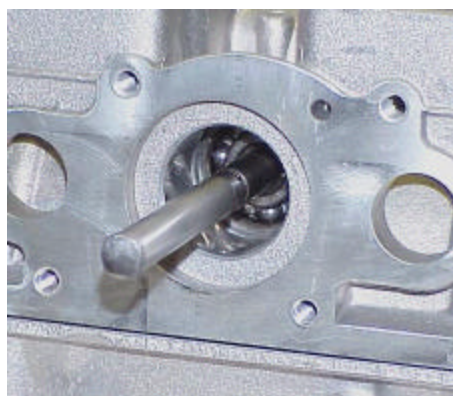
Figure #3 – Removing the RV Shaft can be done with the engine still in the aircraft in most cases. Rotax Tool #876-612 threads nicely onto end of the shaft.

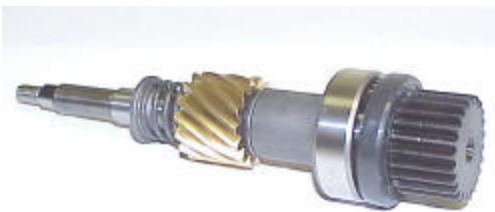
Once the shaft is removed you will find a number of parts assembled shish-a-bob style on the shaft. See Figure #4. Compress the spring and remove all parts for inspection. What you need to look for carefully is any cutting or grooving of the shaft in the area where the #12 seals have been running. Replace shaft if wear is present. Removing the #12 seals means destroying them with a seal hook. Take care not to damage the seal passage.

Figure #4 – With the shaft removed inspect the area where the two #17 seals have been operating. Replace if worn or grooved.

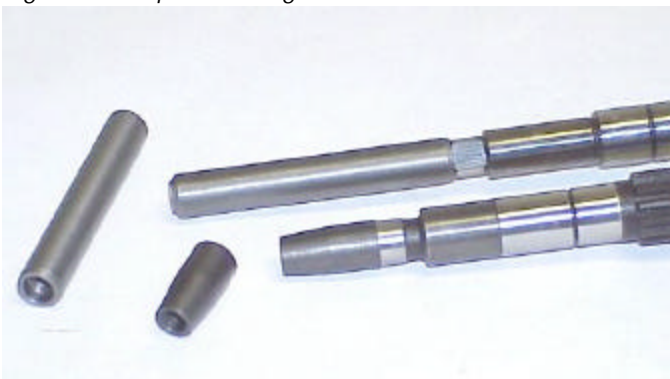
Figure #5 – Rotax makes some inexpensive tools for easy shaft removal and insertion. Both thread onto the end of the shaft.

Reassembling the Shaft: It is advisable to replace all the seals and to inspect the brass gear thoroughly for wear. You can buy the RV Shaft with all the parts already assembled as shown in Fig. #4 Ask for Part #1351. It comes assembled for the price of the parts only. Install the first #12 seal into passage with the flat side facing out. Rotax makes some very nice and very expensive pushers for installing these seals but generally just the right size deep socket will work fine. Apply lithium or silicone grease liberally to the face of the first seal. This is needed to prevent thermal expansion if an air pocket was left between the seals. Install the second seal with the flat side in. Install the shaft back from the intake side making sure the gears mesh without force. Another inexpensive tool from Rotax # 876-980 can be threaded onto the shaft that protects the seals as the shaft is inserted. See Figure #5. Wipe excess grease from area.

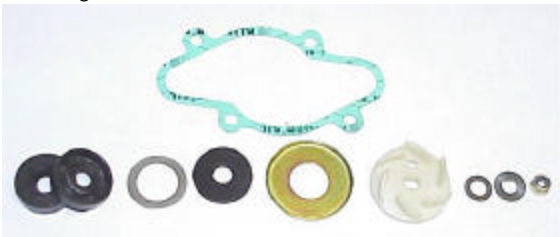
Figure #6 – Several parts after seal pair are now considered optional. The freeze plug and associated parts help prevent seal walk.

There is a progression of parts that are optional after the seals are installed. A shim, rubber disc, and metal freeze plug can be tapped into cavity for extra support to prevent seal walk. See Figure #6 for parts progression. Reinstall water pump impeller and housing.

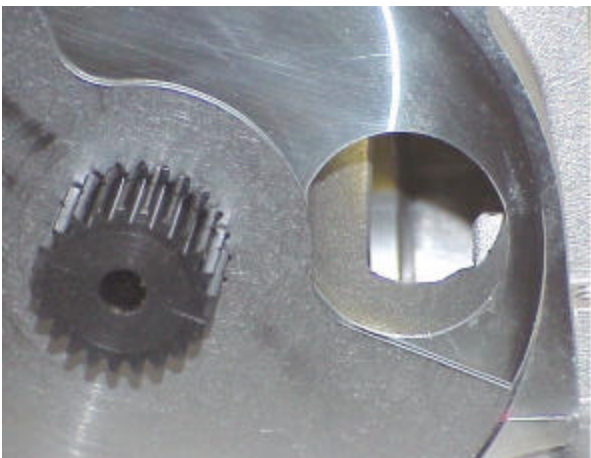
Figure #7 - With the Mag side piston at TDC install the valve plate as shown with the plate right at or just above the bottom of the Mag side port. Flipping the plate over will give a slightly different positioning.

Timing the Rotary Valve Plate: With the Mag side piston at TDC install the valve plate as shown in Figure #7 with the plate right at or just above the bottom of the Mag side port. Flipping the plate over will give a slightly different positioning.

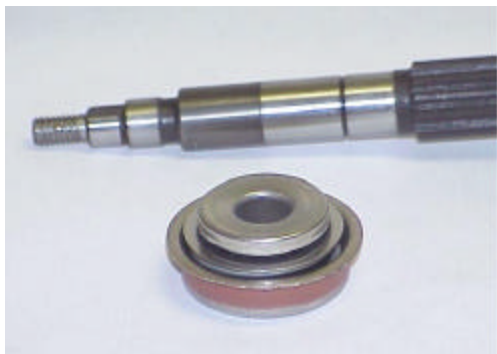
Rotax 582 Model 99: The new blue head 582 is equipped with a new style ceramic Rotary Seal that takes the place of the old rubber seal pair used on previous engines. This set up uses a completely different RV shaft and is not retrofit able to older engines without extensive machining of the seal passage. See Figure #8.

Figure #8 – The new blue head engines have done away with the rubber seals in favor of a new rotary seal and RV shaft. This combination seems to have no problems reaching the 300 hour TBO mark. Order #8777-258 Seal Tool to install delicate ceramic seal.

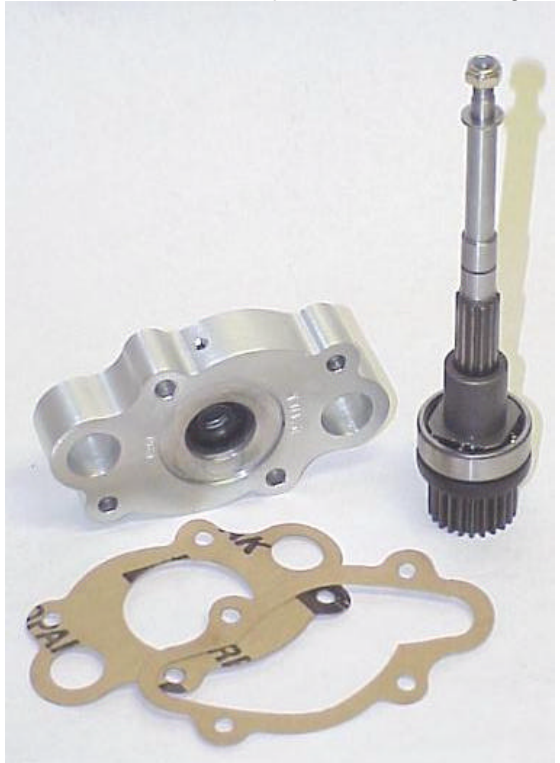
Aftermarket Solutions: Failures of the RV area are common enough for an aftermarket solution to appear. The designer here has come up with an elaborate set up that includes a completely different longer shaft that allows the regular block seals to remain in place and adds an extra pair of seals in a special extension housing. In order for this system to leak you need to lose no less than four seals before a fluid exchange takes place. The other advantage is that to change the outer seals all you need to do is remove the block. The shaft stays put unless it has been grooved. Not a bad fix but with all the new parts you need the conversion is on the expensive side. See Figure #9 for most of the new parts needed for this conversion.

Figure #9 – This aftermarket kit uses a longer shaft plus an extension block to add an extra pair of seals. To change these seals all you have to do is remove the block.

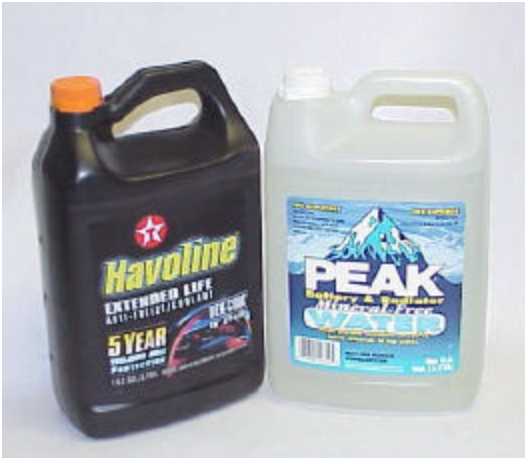
Test have shown that once silica and other contaminates are removed from the coolant the shaft seal cutting problems literally cease to be a factor. Snowmobiles using the same engines have had little trouble with RV seal because the original equipment comes from the factory with the right coolant. Obviously this is not the case for our industry as most aircraft are supplied in kit form allowing the operator to use most anything for coolant.

Figure #10 – Havoline Dex-Cool is a patented formula that is silica free. Mix only with mineral free or distilled water to reduce contaminants.
