What to Know about Prop Strikes

by Mike Stratman

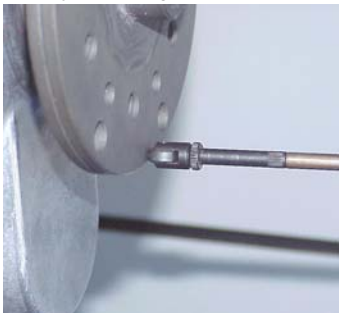
Photo #1 – Check the prop Flange for run out. Maximum of .003" is allowable.

What to look for: First of all, do a full visual inspection of the gearbox housing. Look for cracks in the housing especially around mounting bolts. Remove the remainder of the prop and visually look for a wobble of the prop flange. Measure the run out of the prop flange using a dial indicator parallel to the propshaft close to the outside edge of the flange. This is best done with a roller contact tip fitted to your dial indicator. See photo # .Maximum run out here is .003". If greater than .003" replace propeller shaft.

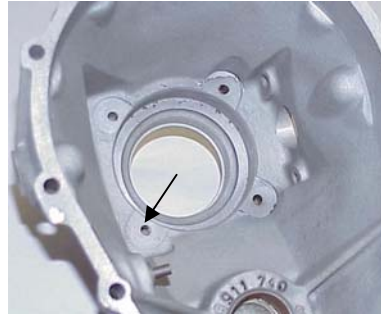
Photo #5 – Check housing area between bolt holes and bearing for cracking and bent bolts. See arrow.

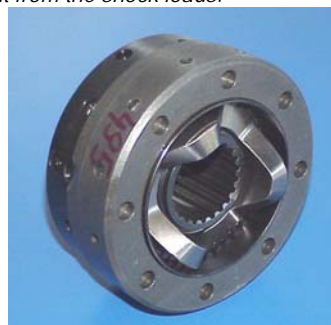
Photo #7 – The overload clutch shown here is now standard equipment on all new 912 series engines. Older engines can be retrofitted for protection from propstrikes and smoother operation.

Rotax 912 Engines with Overload Clutch: All new Rotax 912 and 912S UL engines are now supplied with an overload clutch. This clutch acts similar to an automotive torque converter that allows torsional loads to be dissipated protecting the crankshaft and other drivetrain components. It has always been standard on all certificated Rotax 900 series engines. It can be retrofitted to earlier model engines by a Rotax Service Center or Overhaul shop. See Figure # 6.
